# **SEALING A PIELINE REPAIRS AND REHABILITATION.**

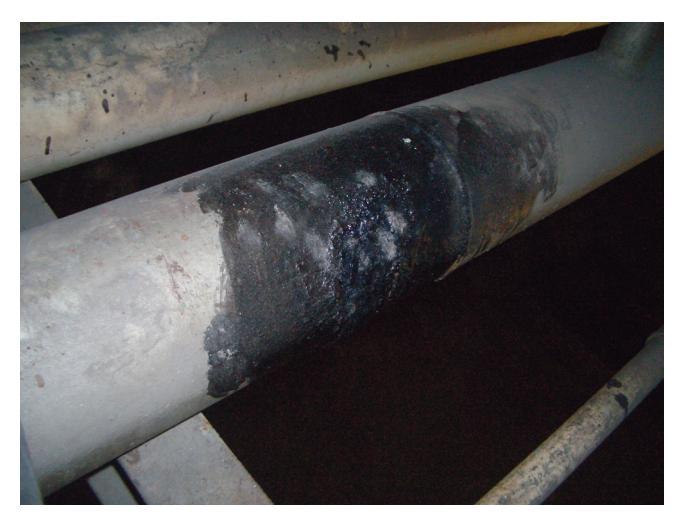
Figure 2. LPG gas pipeline with severe corrosion and leaks on pipe surface.

A liquefied petroleum gas (LPG) pipeline at a glass-manufacturing factory had been plagued with severe corrosion and several locations along the pipe section were observed with major leaks. LPG is a flammable mixture of hydrocarbon gases used as a fuel in heating appliances and vehicles. Unlike any other non-hazardous chemical, LPG can form a flammable mixture with air even in concentrations between 2 - 10%. Also the vapour/air mixtures arising from leakages may be ignited some distance from the point of escape, and the flame can travel back to the source of the leak.

It is indeed a major issue to be addressed off the cuff, as LPG gas leakages when untreated can pose a serious threat to the environment and to humans as well. Engineers from Alstern Technologies were mobilised immediately to the site to understand the crisis and to provide an efficient solution for the leak and corrosion repair. The 10 in. SCH40 carbon steel pipe with an operating pressure and temperature of 150 psig and 30 °C respectively, was found to have many pinholes around the straight, tee and elbow locations. Furthermore, the pipe wall thickness had drastically been reduced due to severe corrosion and pitting.

The flammable nature of LPG gas means that only cold repair was possible on the pipeline, as any hot works would be dangerous under such conditions. The challenge in this project was to seal all the pinholes in order to stop existing leaks and to reinforce the pipe wall to strengthen the pipe to operate at its maximum allowable operating pressure (MAOP). It was therefore decided by the engineers to carry out the repair using SealXpert products.

The repair was successfully completed with the application of Seal Stic<sup>™</sup> steel epoxy onto the pipe to seal off major leak locations. Seal Stic quick cure epoxy sticks are high performance hand-mouldable, metal-filled epoxies with industrial strength. The product mainly finds its

application in repairing and filling holes, cracks and defects. The epoxy sticks are quick-curing and cost-effective in returning worn-off parts or equipment back to service. After the application of the epoxy sticks onto the pipe, Wrap Seal PLUS<sup>™</sup> standard resin and activator was applied onto the pipe surface to stop the corrosion and seal off the pinhole leaks. This is uniquely designed as a corrosion repair system for pipelines, vessels and storage tanks. It acts as a corrosion barrier, remediates and reinforces pipes and tanks. It is to be noted that Wrap Seal PLUS can be used on all metal pipes and pipe fittings. After having halted the leak and taken a preventive action for anti-corrosion, the pipeline reinforcement for the repair location was finally carried out with the wrapping of a fibreglass wrap – the Wrap Seal.

The repair products were allowed to cure based on the respective working conditions and the leak was completely stopped by the time the pipeline was returned to its MAOP. The repair products are a cost-effective solution for leak repair, and proved to be a seamless repair and timesaving as well. The repair system also resulted in additional operational benefits, including minimum labour; easy to apply; and aesthetically perfect results. Since the quick repair system is easy to use in emergency situations, SealXpert products are widely acclaimed in the market, and this is underscored by the company's growth in recent years.

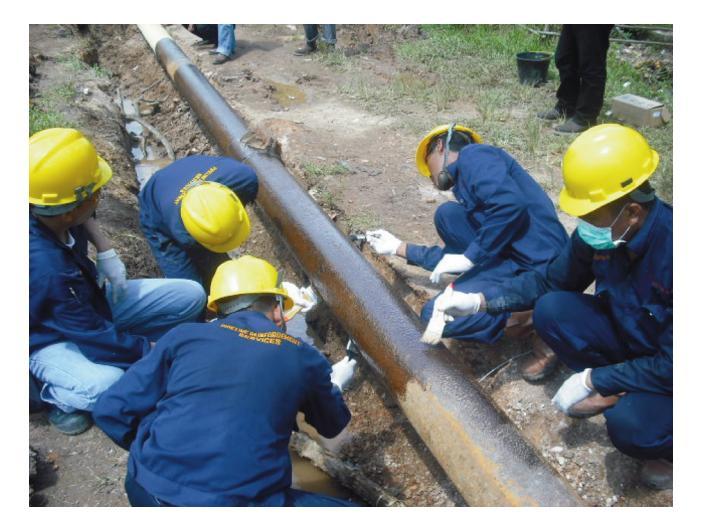
Figure 4. Corroded crude oil transportation pipeline.

Some 6000 m of an 8 in. crude oil transportation pipeline were severely corroded. The pipeline has been in operation for 30 years and needs to be repaired and rehabilitated regularly to ensure its integrity and prolong its service life under an operating pressure of 350 psig. The Wrap Seal PLUS corrosion repair system was used for the pipeline rehabilitation in this project after which fibreglass repair tapes were applied to reinforce the pipe wall thickness. This pipeline rehabilitation project was completed successfully in three months.

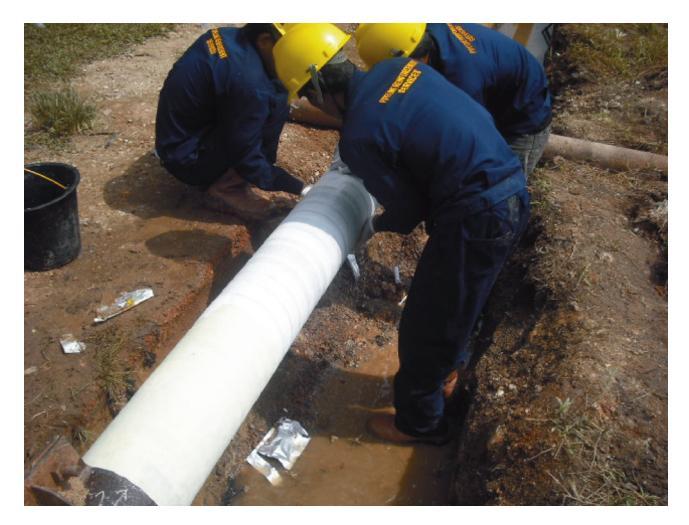
Figure 5. Pipeline after reinforcement.

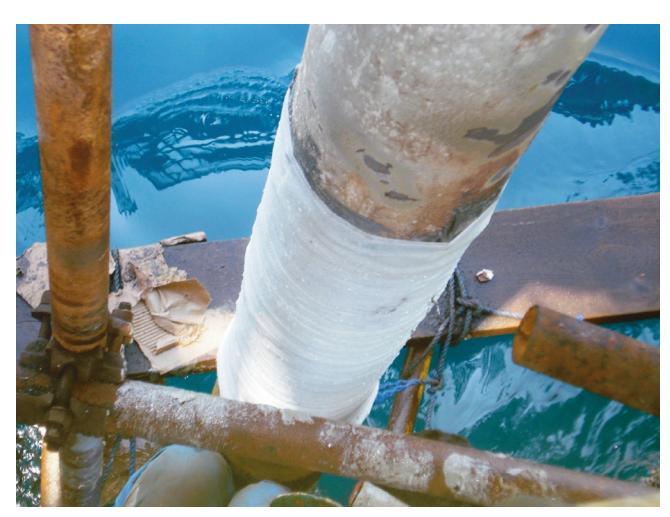
Figure 6. Pipe condition after repair and reinforcement.
